FLOWPA FUNDAMENTALS

FINGER LAKES - LAKE ONTARIO WATERSHED PROTECTION ALLIANCE
FROM STREAMS, TO LAKES, TO GREAT LAKES
PROTECTING OUR WATER RESOURCES BEGINNING AT THE LOCAL LEVEL

FLOWPA STREAMBANK STABILIZATION PROJECTS

FALL 2019

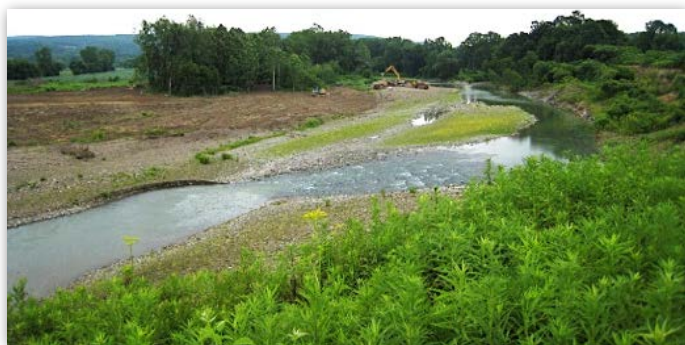
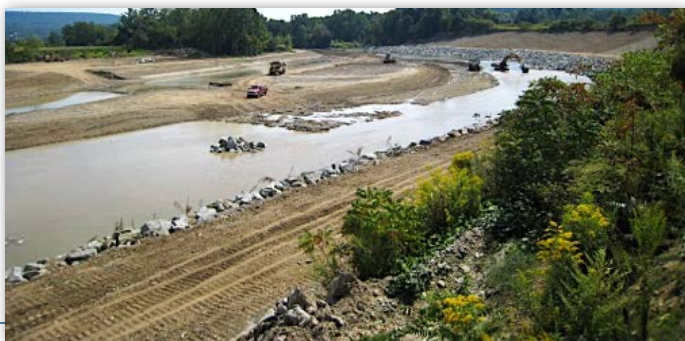
Two sites along the Genesee River were mitigated for excessive bank erosion and their imminent threat to major roadways and the railroad. Vertical eroding banks in excess of 30 feet were a significant source of sediment to the Genesee River. FLOWPA funds of \$16,240 were used to support the design, easement securing, engineering, permit application process and the leveraging of FEMA pre-disaster Hazard Mitigation funds for construction. This project also helped the SWCD secure \$3,000,000 in State and Federal funding to repair major erosion issues along Genesee River.

Before and after photos of the Genesee River stabilization project.

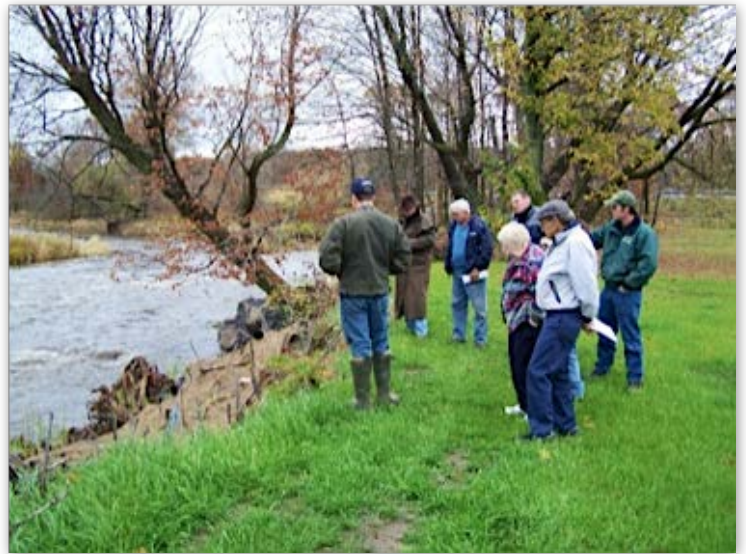
Natural stream channel design was used to stabilize the stream. Native woody material, called toe wood was installed, while soil lifts wrapped in biodegradable fabric were placed on top of the woody material and then willow stakes were driven into the soil. As the willows grow, they will protect the bank from future erosion. In total, 1,660 feet of toe wood structures were installed on six severely eroding sites.

In stream features were also incorporated into this project including a grade control structure to help create a pool. Two channel blocks were installed with J-hooks to redirect the flow path and 590 feet of rock stabilization was installed. Riparian forest buffers were established along the banks. The trees will provide shade to reduce the water temperature, create habitat for wildlife, filter field runoff and their root systems will help stabilize the banks.

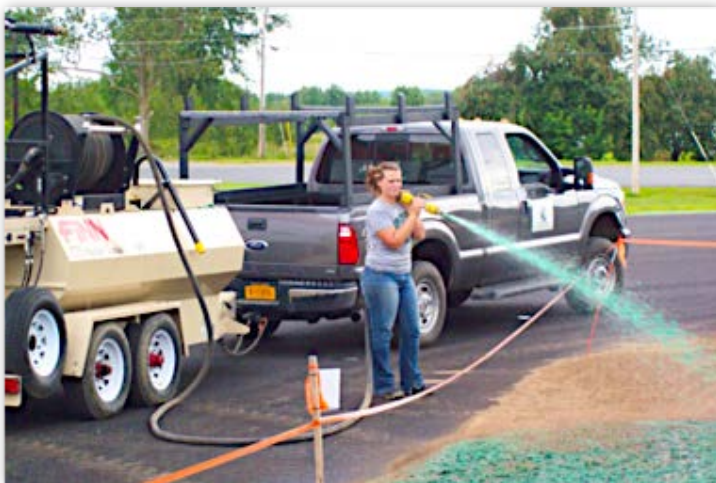
FLOWPA has contributed \$223,700 to Lewis County SWCD's hydro seeding program since it was established in 2003

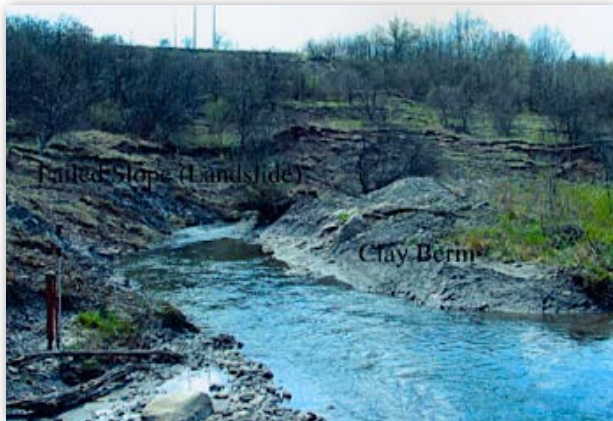
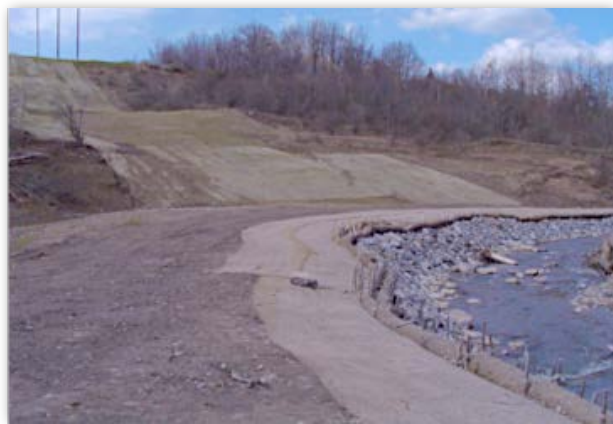
A beaver dam redirected Limestone Creek, a well-known trout stream, resulting in erosion of the toe of a slope causing a massive landslide in Madison County in 2002. The redirected stream course eroded the collapsed hillside depositing significant sediment into the stream. Turbidity in the creek caused visual impacts, reduced water quality and threatened trout survival.

The main goals of the project were to restore Limestone Creek to its natural course, determine the possible causes of the landslide, and stabilize the remaining slope. An additional goal included restoration of its riparian corridor to improve the creek's stability using a natural stream design. Initial project results were extremely positive, and despite some setbacks from high flows in subsequent years, the stream and slope have now reached a state of balance and water quality is vastly improved. The total project cost was approximately \$285,000, of which \$50,000 came from FLOWPA.

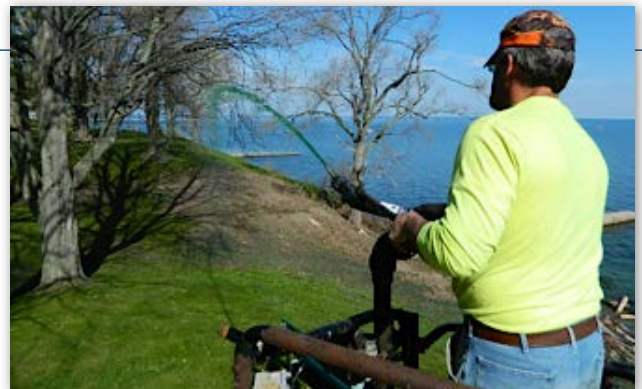
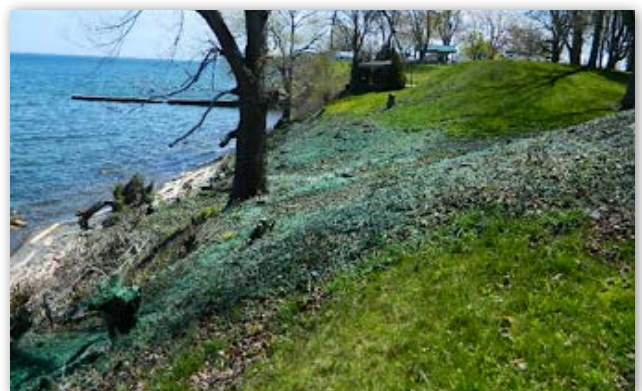
Niagara County Parks Department, assisted by Niagara County SWCD hydroseeded shoreline in Krull Park in the Town of Newfane along Lake Ontario in 2016. The lake bank with an elevation change of 35 feet on a 2:1 slope was seeded with native grasses and forbs to re-establish vegetation. The vegetation will reduce the potential for erosion and the native grass and wildflower mix will provide habitat for birds and pollinators. Eliminating the potential source of sediment load to Lake Ontario, this project also provides water quality benefits.

Approximately 485 lineal feet of (0.7 acres) of shoreline area were hydroseeded to prevent erosion and provide wildlife habitat. The total project cost was \$2,400 and FLOWPA contributed \$1,000.

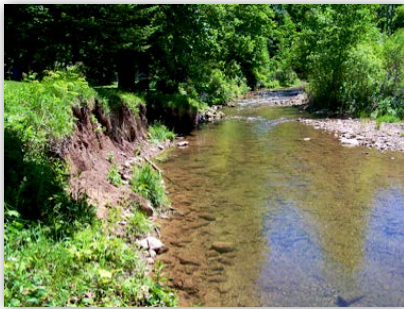
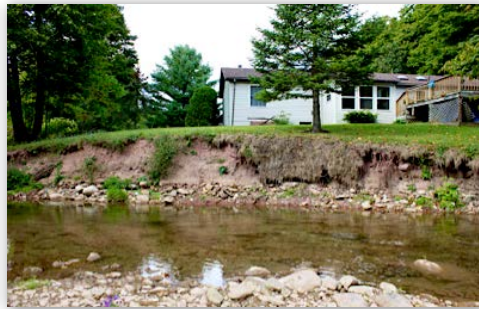
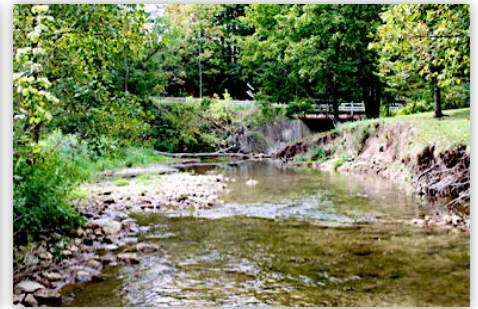
Oneida County SWCD, USFWS and a landowner worked together to install approximately 120 linear feet of stream restoration using Rosgen's toe wood method. Large woody debris was used to stabilize the toe of the eroding bank without damaging habitat. The toe wood is constructed by pre-excavating a trench at the toe of the slope, installing footer logs parallel with the bank and then root wads perpendicular to the flow on top of the footer logs. The root wads were spaced approximately seven feet apart and were submerged below the low water elevation. Willow whips were placed above the root wads along with a thick layer of inert brush to provide a foundation for a soil lift. The soil lift is wrapped in a coconut fiber twine fabric and overlapped and shingled such that the upstream fabric overlies the downstream section. The entire soil lift is seeded with a conservation seed mix both before and after the fabric is wrapped over the top. Wooden stakes were pounded into the seams of the fabric. Live willow stakes were also installed into the top of the soil lift in order to encourage re-vegetation. The project largely withstood storm damage a year later, when nearly 5" of rain fell in 27 hours. Photos show before, during construction, and four days after a storm event one year after construction.

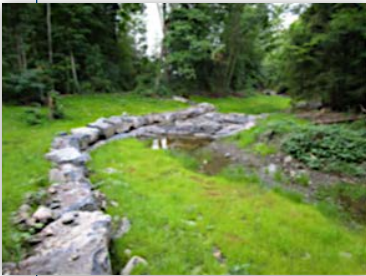
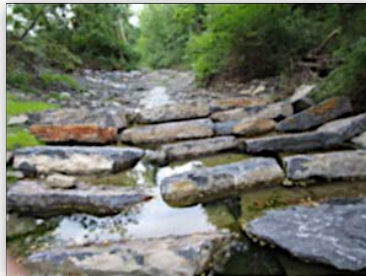
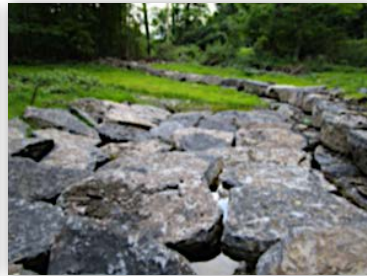
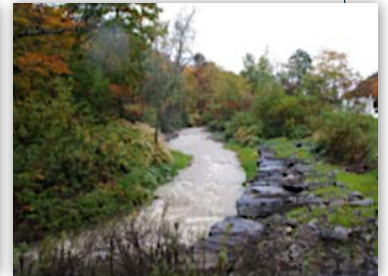
Catlin Mill Creek is a protected trout stream that is a direct tributary of Catharine Creek, a world renowned trout stream that is a direct tributary of AA drinking water source of Seneca Lake. Severe erosion was threatening stream habitat and health, four homes, and their associated septic systems, the Town of Hector gravel pit and NYS Route 228.

Schuyler County SWCD with assistance from the towns of Catharine and Hector Highway Departments utilized \$19,000 in FLOWPA funds to stabilize over 2,000 feet of significantly eroded streambank along Catlin Mill Creek utilizing rock and willow structures. NYS Water Quality Improvement Program provided over \$50,000 to purchase rock. Over \$20,000 of in-kind time and equipment was contributed by the municipalities and Schuyler County SWCD.

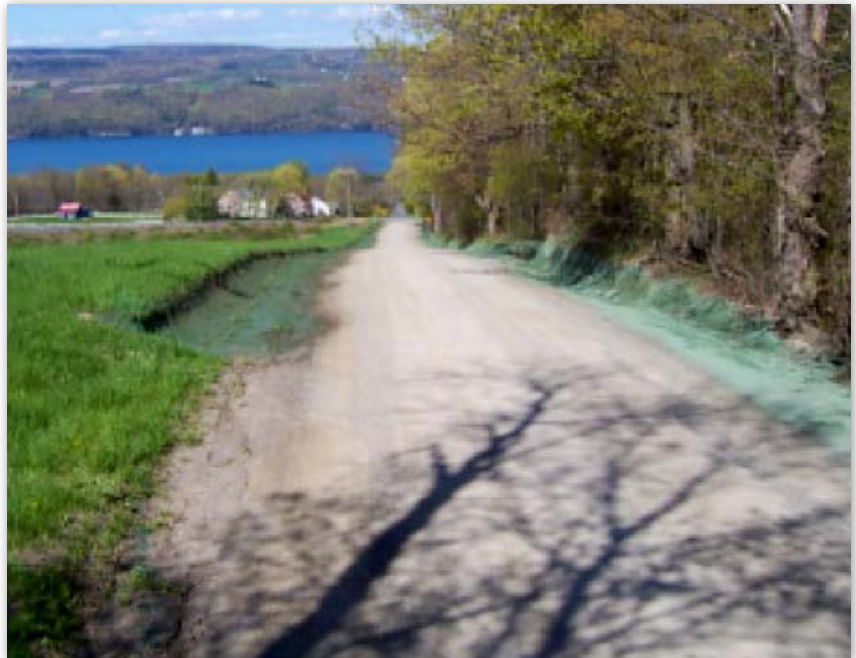
Critical area seeding has been a major component of the Schuyler County SWCD's FLOWPA program for the last 20 years. The program originally started with the purchase of hand seeders for all municipal highway departments. Seed was provided to them so they could hand seed areas they disturbed immediately after excavation. The program then grew in participation and acreage and the District was able to obtain a bale mulcher through the FLOWPA program for all of the District projects, all municipal projects, and many private ponds, diversions, and waterways. From 2008 to today, the Schuyler County SWCD has been utilizing a hydroseeder. This hydroseeder was purchased with member item funding and is used by the District to seed all excavated municipal road ditches, all stream stabilization projects, and many agricultural projects the District implements, along with private ponds, waterways, and diversions.

From 2008 through 2016 over 560 acres were seeded throughout the county by partnering with towns, villages, highway departments, private farms and landowners. Nearly \$50,000 of FLOWPA funding was used to purchase materials. Schuyler County SWCD and its municipalities provided \$57,600 in manpower and \$96,000 in equipment time. The one-ton truck and hydroseeder were purchased with \$75,000 of member item and local funds.

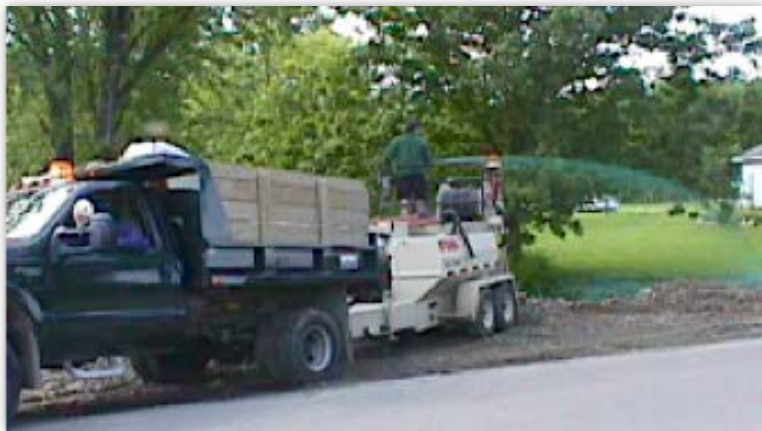
Since 1988, Steuben County SWCD has operated a hydroseeding program dedicated to controlling sediment loading and erosion from critical areas. The District has cost shared with municipalities and the County to revegetate exposed soil from construction projects, in addition to stream banks, road ditches, gravel pits, and urban development.

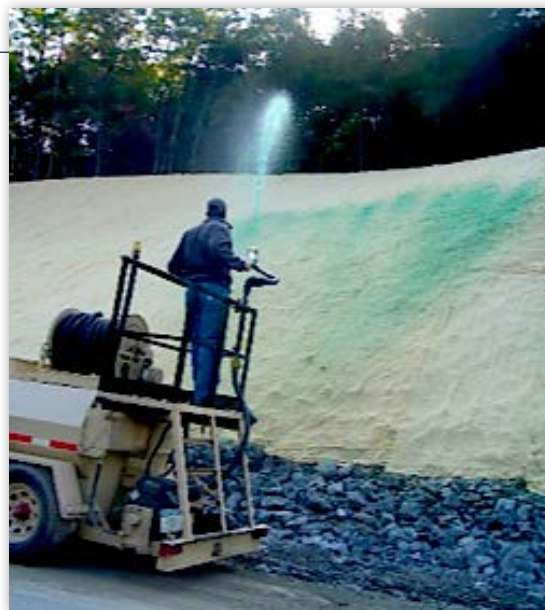
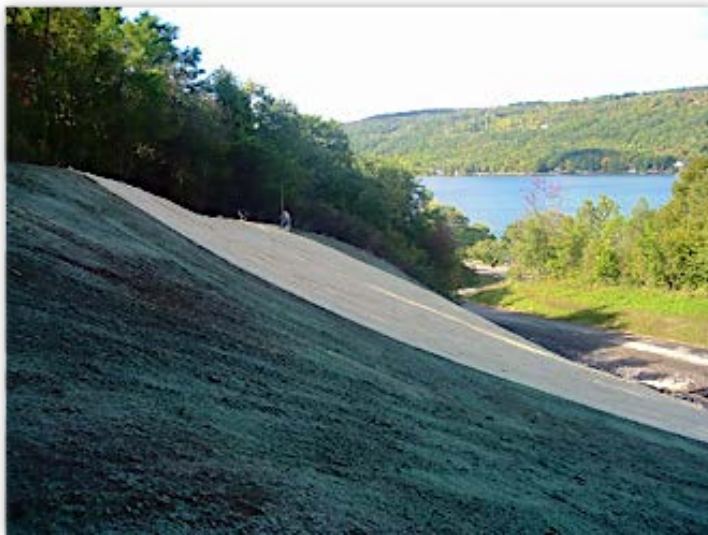
The Town of Barrington (Yates County) was dealing with an unstable slope adjacent to a town road right of way for many years. This unstable slope was contributing large amounts of sediment to the road ditch that eventually discharged into Keuka Lake approximately six hundred feet away.

In 2006 Yates County SWCD's FLOWPA program partnered with the Town of Barrington Highway Department to address this water quality issue. FLOWPA funds provided the technical staff resources to develop a corrective action plan and provide labor and materials to re-establish vegetation to the finished project to protect and stabilize the soils. The Town of Barrington provided the labor and equipment to implement the project which included reshaping the bank to a stabilized slope angle and reshaping and rock armoring the down slope road ditch to prevent erosion. FLOWPA technical assistance funds (\$8,000) were used for design, implementation and materials. The Town Highway Department spent approximately \$30,000 in labor and equipment to implement the project.
